165726 – JOINERS SHED, PORTKNOCKIE

We confirm that we carried out an inspection of the above property. The inspection was carried out with regard to the condition of the building after a recent fire.

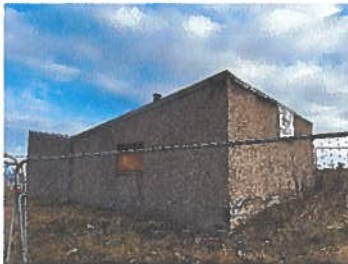
The property is a single storey joiners shed built from blockwork. The shed has been extended with a blockwork extension to the North end.

The original roof is formed with steel profiled sheeting supported on timber purlins spanning from the side walls over 2 intermediate steel beams. The extension roof is formed with steel profiled sheeting supported on timber battens spanning between timber rafters. The roofs span towards the junction between the original building and extension where there is a valley gutter.

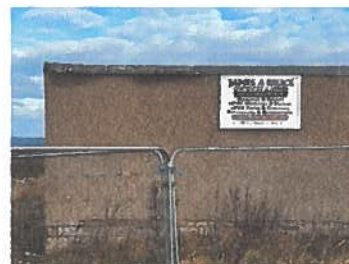
There is a large diagonal crack in the south elevation of the building. The crack is along the full height of the rendered wall. There is a horizontal crack near the top of the wall which crosses over the diagonal crack.

The roof verge and courses of block immediately below are noticeably scorched with deformation present in the cladding of the verge.

The blockwork from the west-most pier of the south elevation to the junction with the extension on the west elevation should be taken down and rebuilt on the existing foundations.

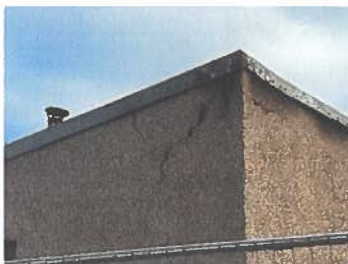
Cracking is noted on the west elevation of the building near to the corner of the south elevation. The crack is diagonal and runs the full height of the wall. The blockwork at the south corner of the west elevation is badly scorched and there are scorch marks present within the cracking near the top of the wall.

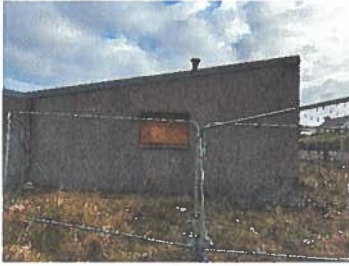
Large cracks are noted around the window opening of the west elevation. The cracks are at the north side of the window and run vertically from the sill to ground and from mid height of the window to the roof line.

Along the west and south elevations there are areas where the render has de-bonded and spalled away from the blockwork

The sealant at the junction between the original building and the extension has become loose and is missing in places on the west elevation.

The blockwork in the south west section of the building has been badly scorched with movement and cracking noted. We would recommend that the blockwork be taken down from the west-most pier on the south elevation to the junction with the extension on the west elevation. The walls can be rebuilt off the existing foundations with suitable wall ties installed to connect the rebuilt section to the existing blockwork. The junctions should have a suitable flexible sealant installed as well.

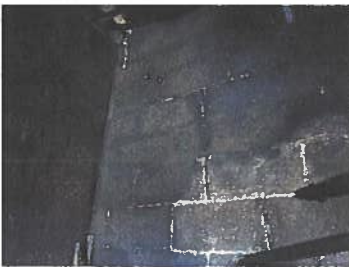
The inside of the original building has been affected by fire damage. The blockwork along the south and west elevations are noticeably scorched.

Cracking is present in the blockwork and mortar at the south west corner of the building. The cracks are larger near the roof line of the building. The blockwork to the east of the west-most pier is in better condition with no cracking noted.

The timber purlins within the original building are badly charred with a significant loss of section noted at the junction with the west elevation. The steel sheeting, where visible, is also cracked and flaking.

The roof of the original building should be completely removed above the steel beams and replaced with suitable matching roof structure. The steel beams are in a reasonable condition and can be retained. They should be cleaned back to bright steel and repainted with a suitable protective treatment.
