Home Report

Scottish Single Survey

Property address	Dunrobin Green Street AB38 7BD
Customer	David Simpson
Customer address	Dunrobin Green Street AB38 7BD
Prepared by	Shepherd Chartered Surveyors
Date of inspection	16/03/2023

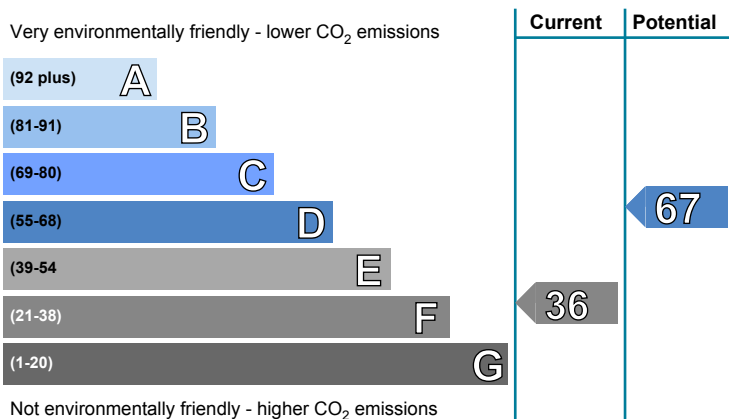
Environmental Impact (CO₂) Rating

This graph shows the effect of your home on the environment in terms of carbon dioxide (CO₂) emissions. The higher the rating, the less impact it has on the environment.
