Home Report

Scottish Single Survey

Property address	9 Duncan Avenue Fochabers IV32 7HW
Customer	Mr Ian Davidson
Customer address	9 Duncan Avenue Fochabers IV32 7HW
Prepared by	Shepherd Chartered Surveyors
Date of inspection	02/05/2024

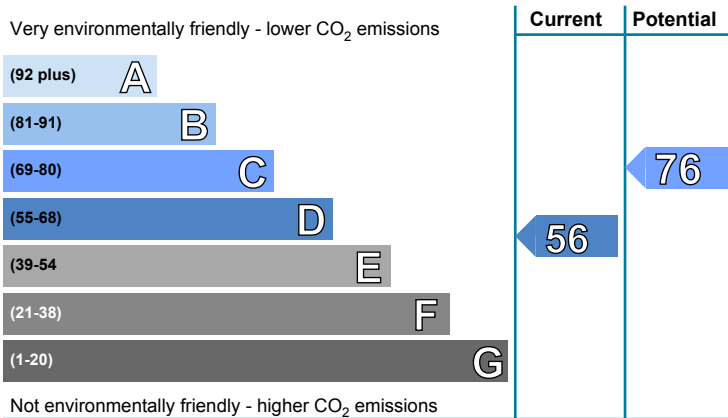
Environmental Impact (CO₂) Rating

This graph shows the effect of your home on the environment in terms of carbon dioxide (CO₂) emissions. The higher the rating, the less impact it has on the environment.
