Home Report

Scottish Single Survey

Property address	57 King Street Burghead Elgin IV30 5XG
-------------------------	---

Prepared by	Shepherd Chartered Surveyors
--------------------	------------------------------

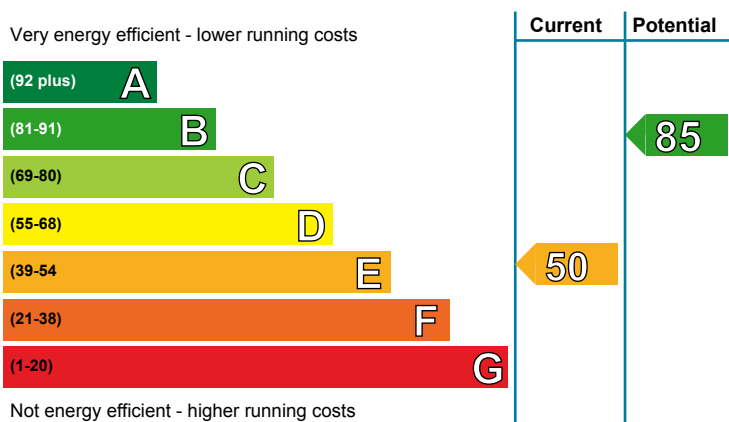
Energy Efficiency Rating

This graph shows the current efficiency of your home, taking into account both energy efficiency and fuel costs. The higher this rating, the lower your fuel bills are likely to be.

Your current rating is **band E (50)**. The average rating for EPCs in Scotland is **band D (61)**.

The potential rating shows the effect of undertaking all of the improvement measures listed within your recommendations report.

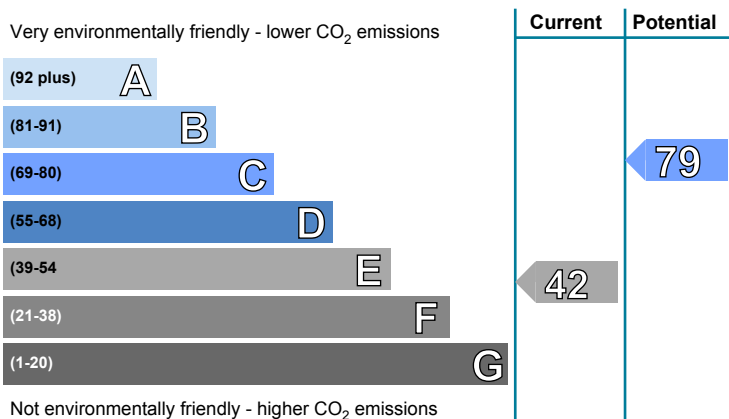
Environmental Impact (CO₂) Rating

This graph shows the effect of your home on the environment in terms of carbon dioxide (CO₂) emissions. The higher the rating, the less impact it has on the environment.
