YOUR ONESURVEY HOME REPORT

16 St Ronan's Terrace
Innerleithen
EH44 6RB

SINGLE SURVEY

Single Survey

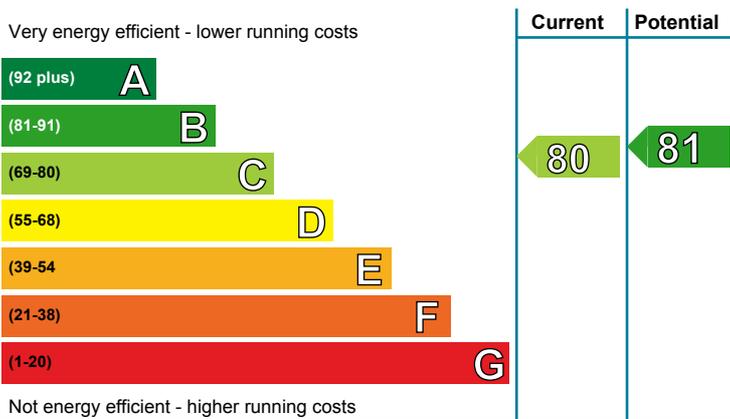
Energy Efficiency Rating

This graph shows the current efficiency of your home, taking into account both energy efficiency and fuel costs. The higher this rating, the lower your fuel bills are likely to be.

Your current rating is **band C (80)**. The average rating for EPCs in Scotland is **band D (61)**.

The potential rating shows the effect of undertaking all of the improvement measures listed within your recommendations report.

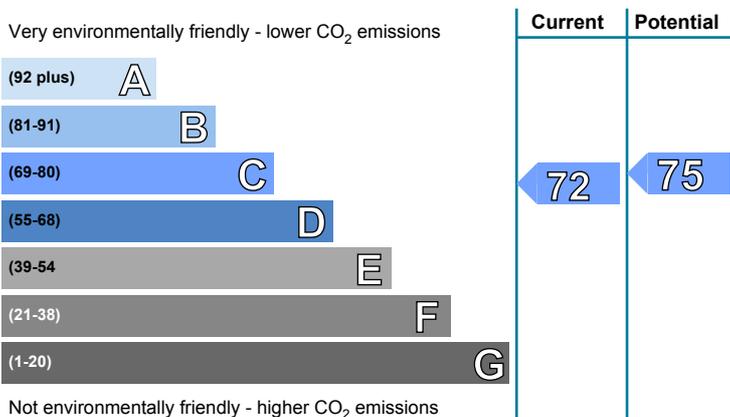
Environmental Impact (CO₂) Rating

This graph shows the effect of your home on the environment in terms of carbon dioxide (CO₂) emissions. The higher the rating, the less impact it has on the environment.
