# HOME REPORT

**Eilean Donan Portsonachan Lodges**

**Dalmally  
PA33 1BJ**

# Single Survey

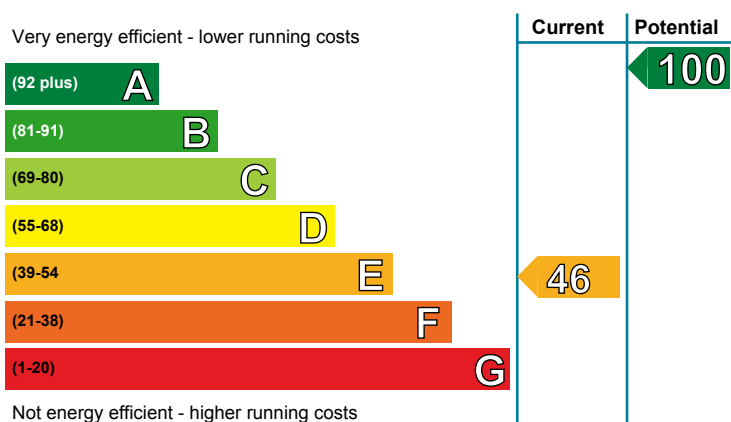
## Energy Efficiency Rating

This graph shows the current efficiency of your home, taking into account both energy efficiency and fuel costs. The higher this rating, the lower your fuel bills are likely to be.

Your current rating is **band E (46)**. The average rating for EPCs in Scotland is **band D (61)**.

The potential rating shows the effect of undertaking all of the improvement measures listed within your recommendations report.

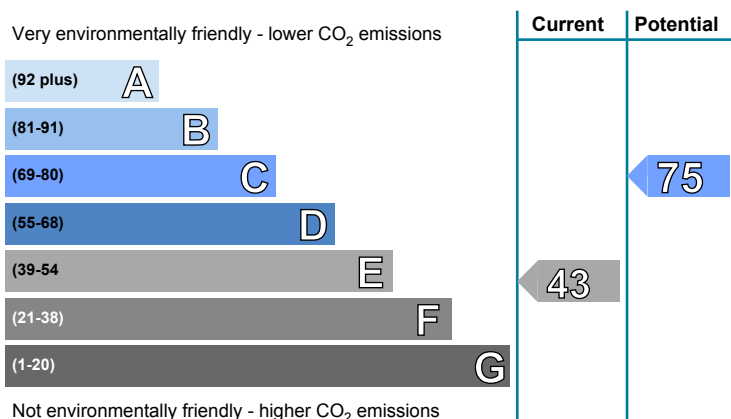
## Environmental Impact (CO<sub>2</sub>) Rating

This graph shows the effect of your home on the environment in terms of carbon dioxide (CO<sub>2</sub>) emissions. The higher the rating, the less impact it has on the environment.

Your current rating is **band E (43)**. The average rating for EPCs in Scotland is **band D (59)**.

The potential rating shows the effect of undertaking all of the improvement measures listed within your recommendations report.
