YOUR ONESURVEY  
**HOME REPORT**

The Granary  
Beach Road  
Kingston, Fochabers  
IV32 7NP

# SINGLE SURVEY

# Single Survey

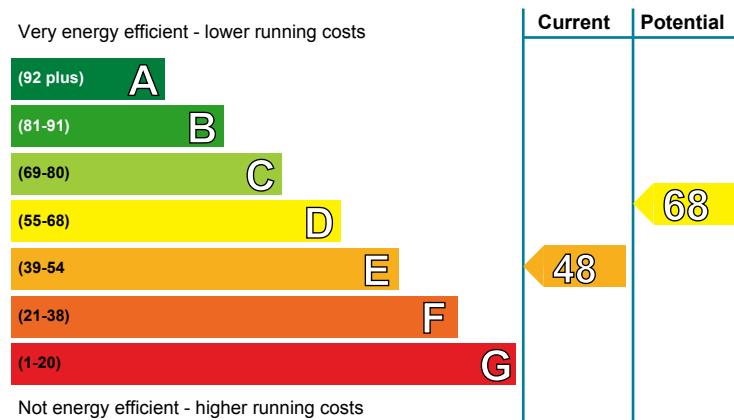
## Energy Efficiency Rating

This graph shows the current efficiency of your home, taking into account both energy efficiency and fuel costs. The higher this rating, the lower your fuel bills are likely to be.

Your current rating is **band E (48)**. The average rating for EPCs in Scotland is **band D (61)**.

The potential rating shows the effect of undertaking all of the improvement measures listed within your recommendations report.

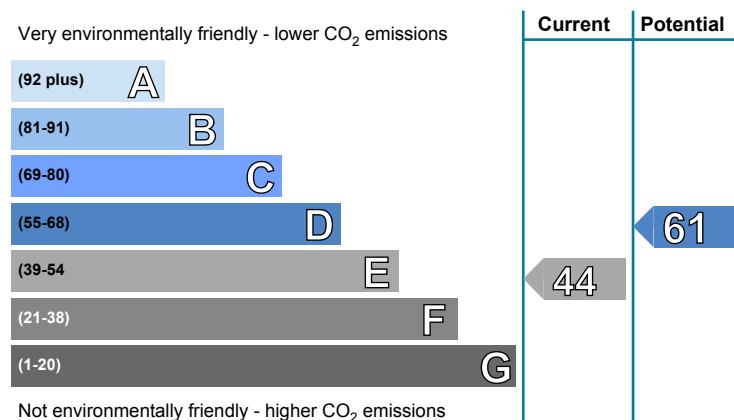
## Environmental Impact (CO<sub>2</sub>) Rating

This graph shows the effect of your home on the environment in terms of carbon dioxide (CO<sub>2</sub>) emissions. The higher the rating, the less impact it has on the environment.
